DuOtherm Warm Roof on Steel Monkey Toe Walkway Fixing Detail

Drawing No: **DBDTS-D12**
Scale: 1:4 @ A4
Drawn by: NKT
Date: 30/10/2017

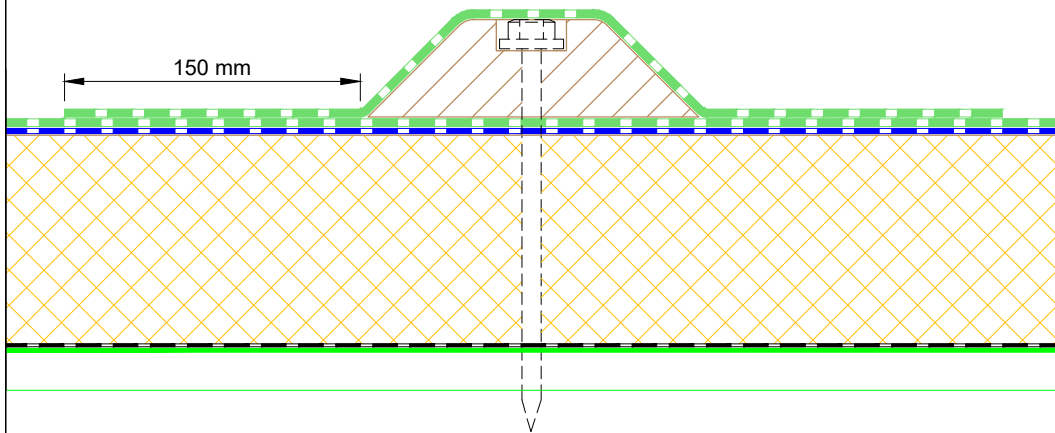
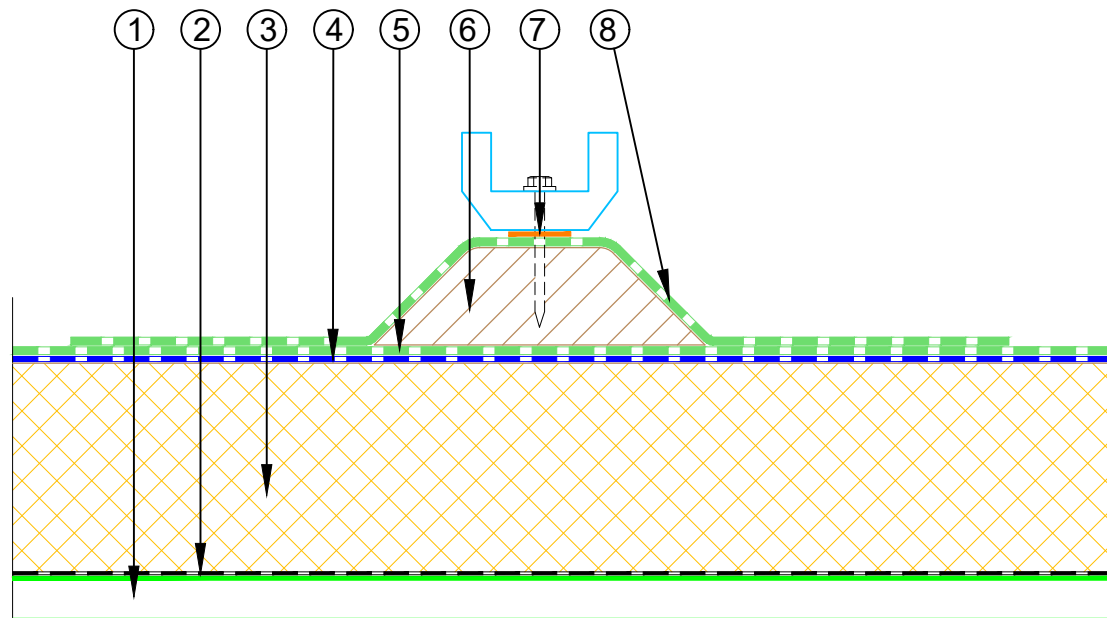
- ① New Corrugated Metal Roof (0.75 gauge minimum)
- ② Equus Vapour Barrier
- ③ Equus PIR Thermal Insulation Board
- ④ Equus/De Boer Basesheet
- ⑤ Equus/De Boer Capsheet DuO HT 4 Slates/F C180 FireCare
- ⑥ Timber Plinth
- ⑦ Monkey Toe Roof Profile Fixing with Neoprene Washer
- ⑧ Equus/De Boer Capsheet, as separate piece over Timber Plinth

STEP 2: Fixing of the Monkey Toe Roof Profile

STEP 1: Fixing of the Timber Plinth
